## **AQUEDUCT COTTAGE**

### **RESTORATION MEMORIES - March-October 2020 : Covid Lockdown**

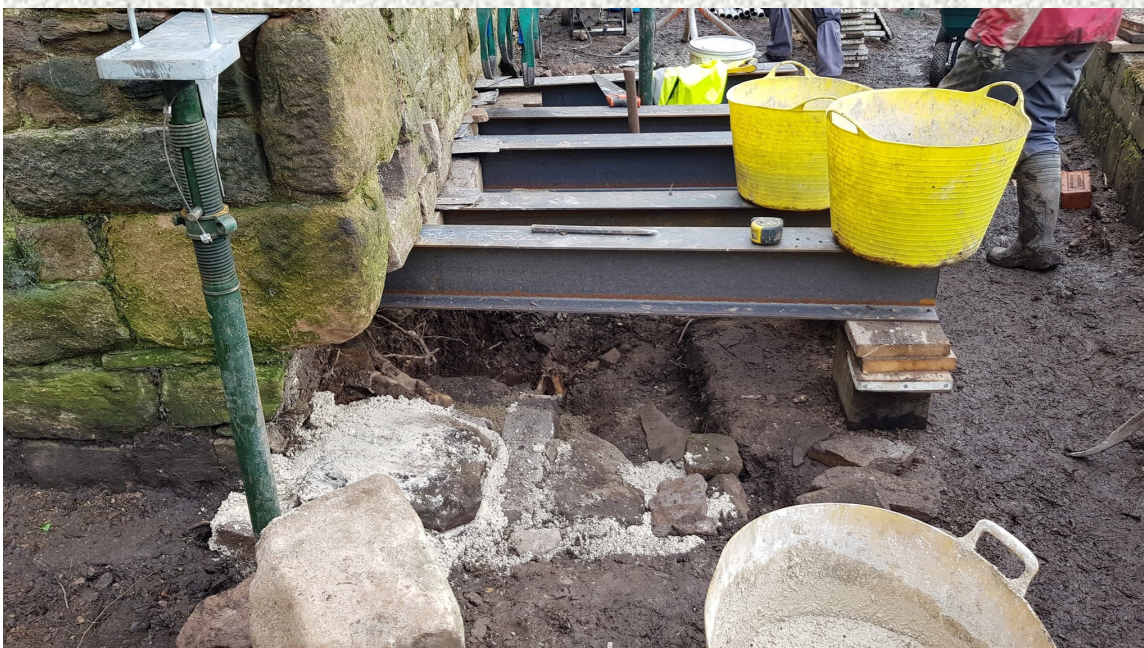
***Underpinning the cottage. The corner of the building was supported by several steel beams until a new foundation of stone was built.***

**Our builder, [Andrew Churchman Ltd](#) started work in January 2020. His first task was to underpin the front left corner of the cottage. A gaping hole was left from a large tree root removed that over the years had buried its way under the corner. All was going well until March 10th when Boris announced the start of the first Covid lockdown and life as we knew it came to a stop.**

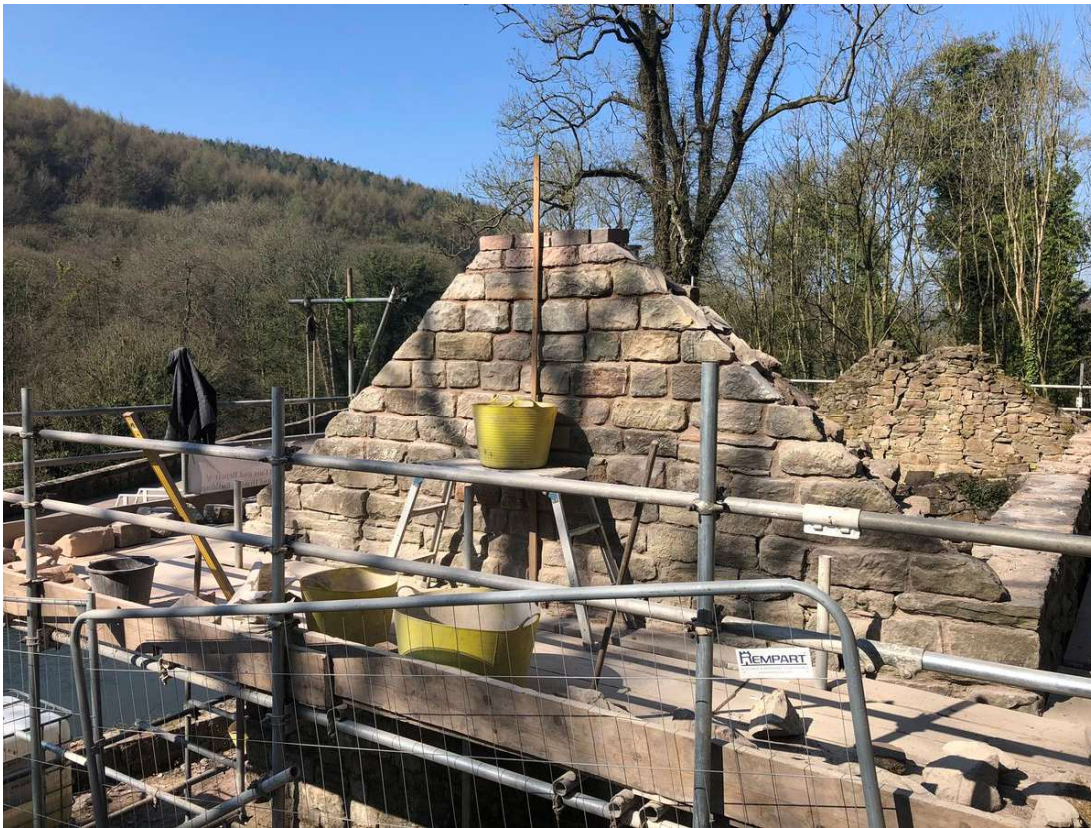
***Reclaimed stone matched to the original stone-work was used in the reconstruction of the gable ends.***

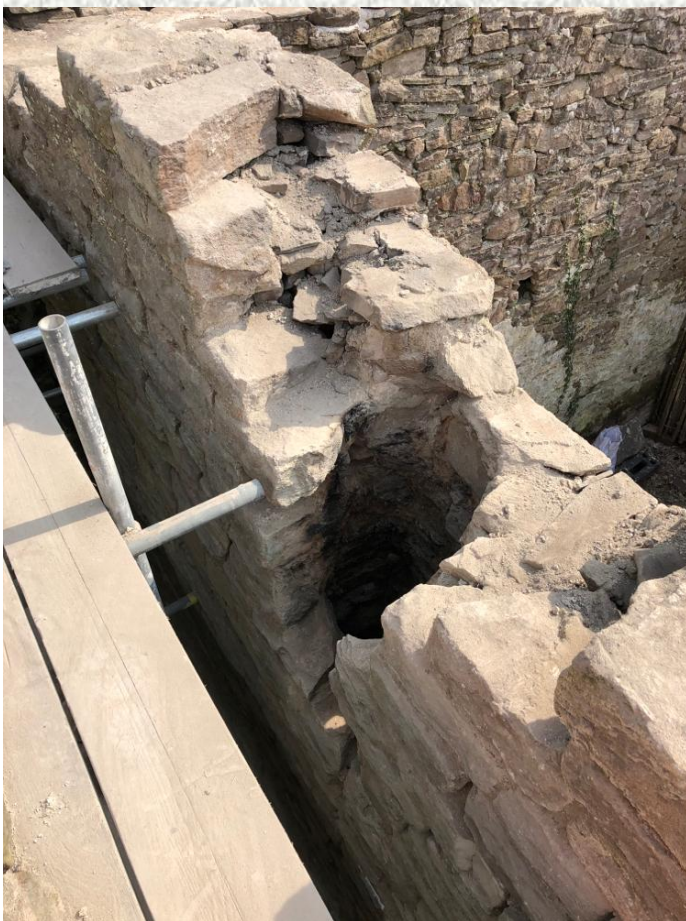
***The north gable end was in such a poor state the top half had to be dismantled.***

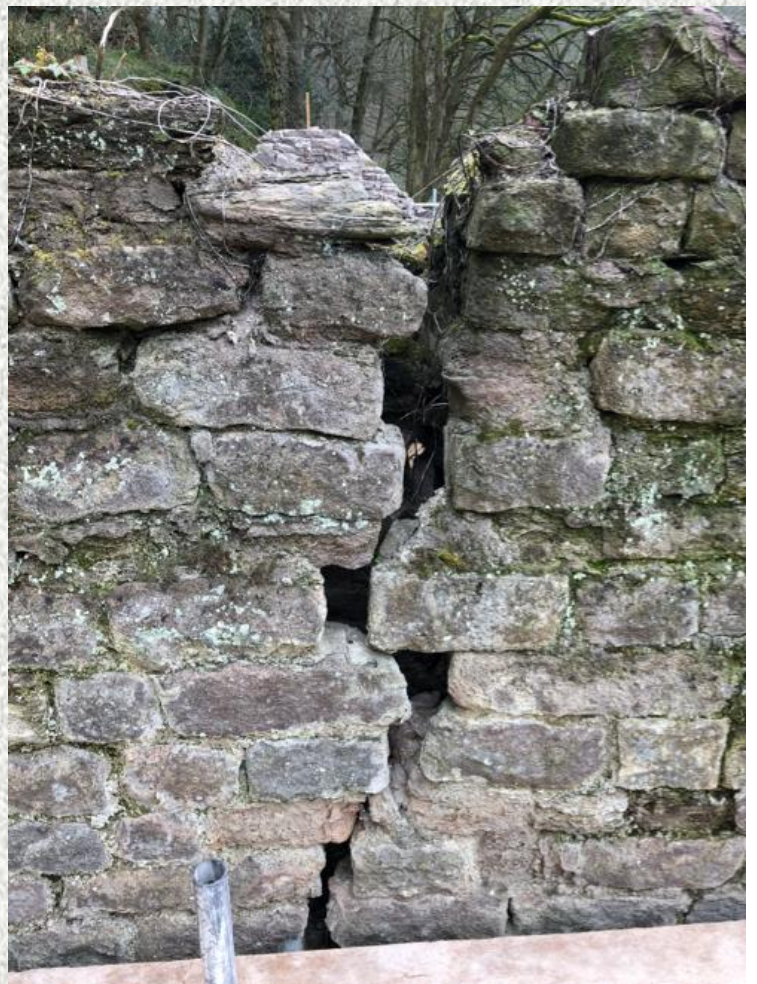
***The large crack in the north gable end before being dismantled.***

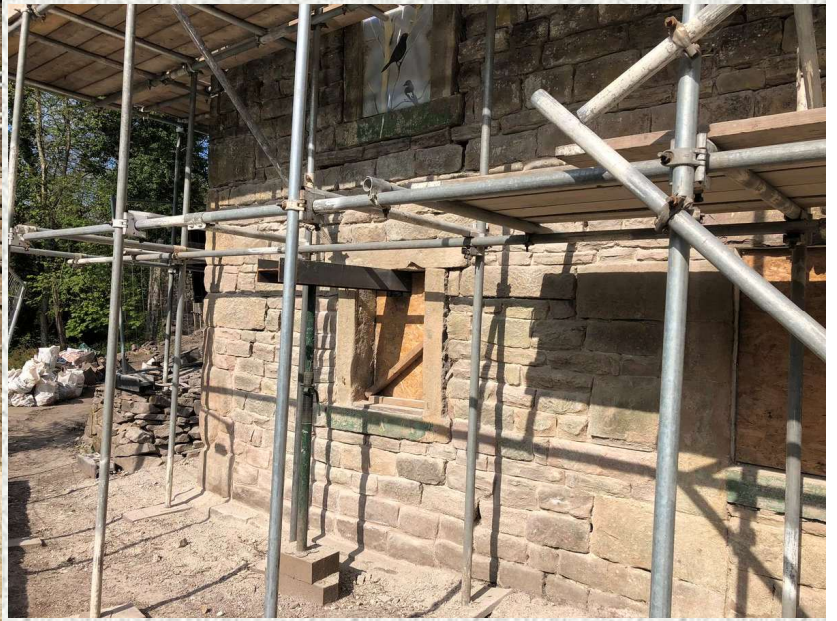
***Under-pinning complete.***

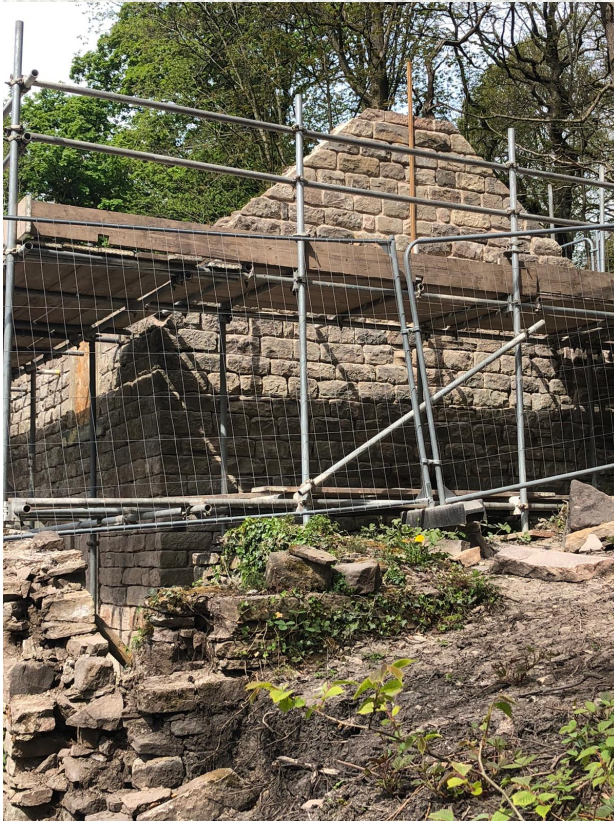
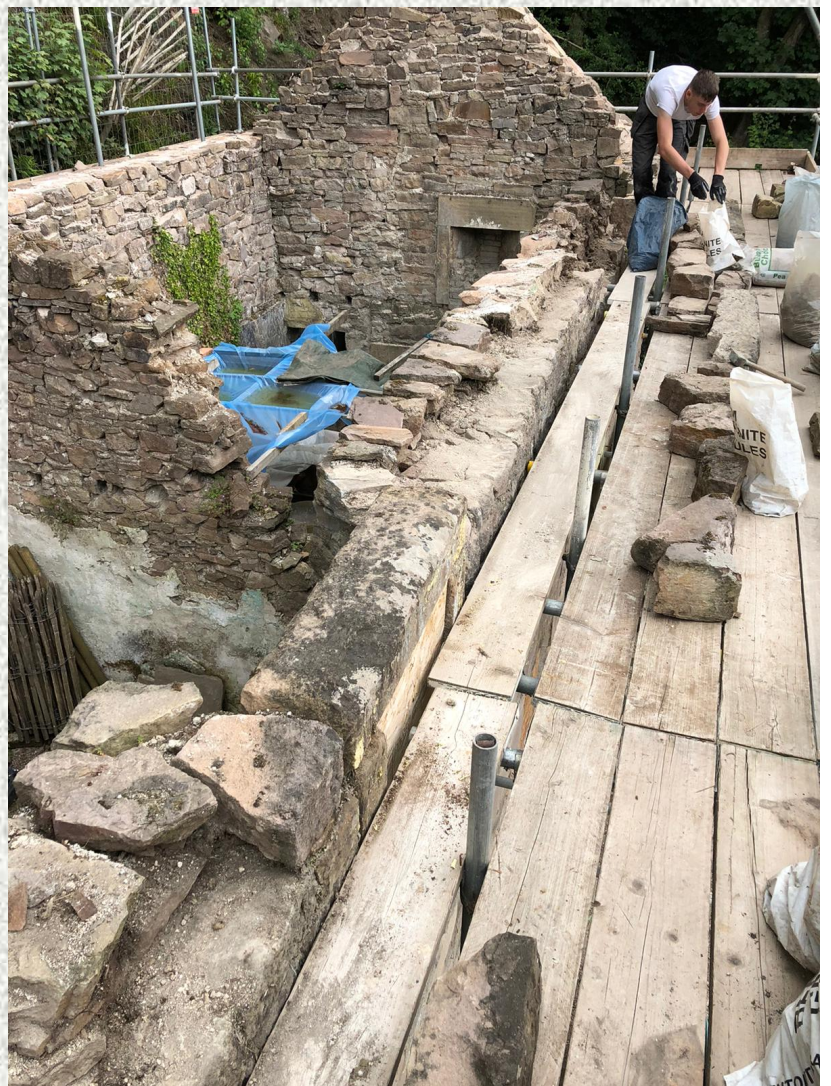
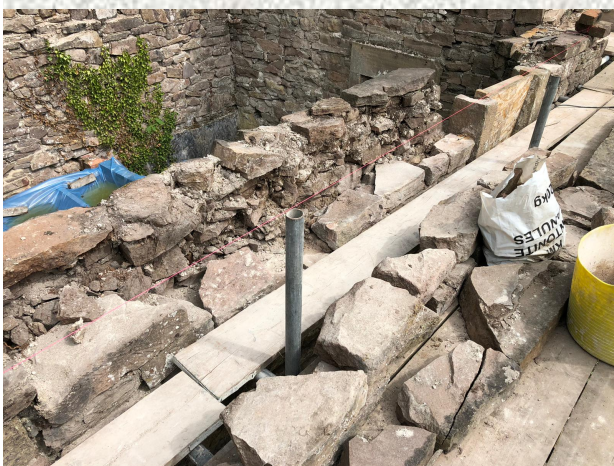
***The top three courses of the front and rear walls were dismantled and rebuilt.***

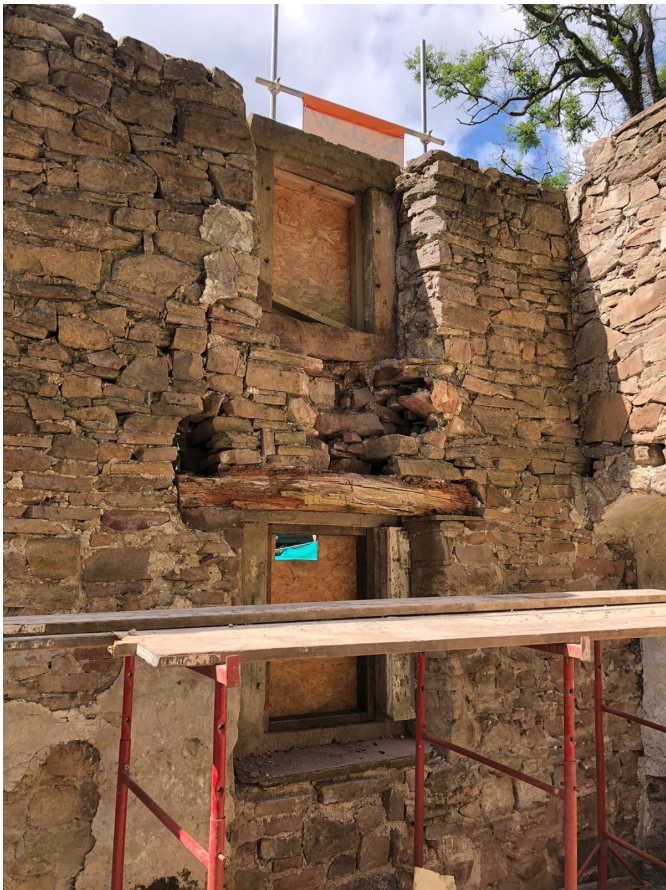
***Part of the wall had to be removed to replace one or both of the oak lintels above the windows.***

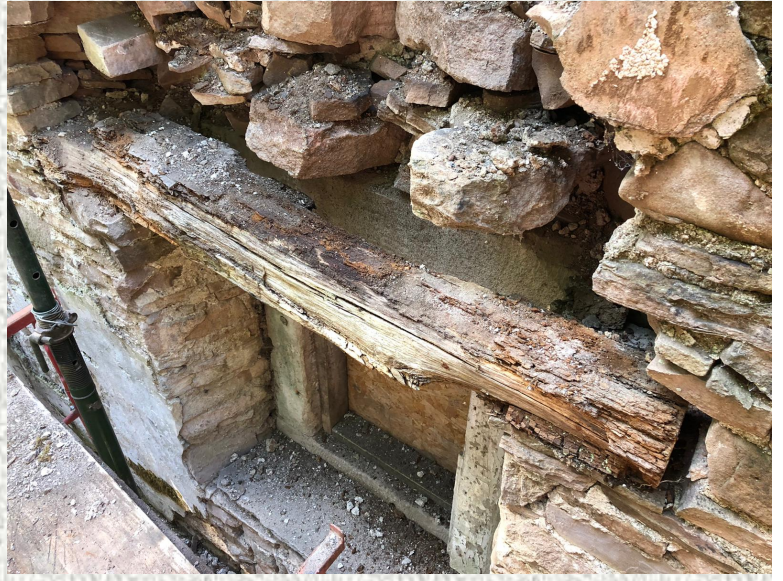
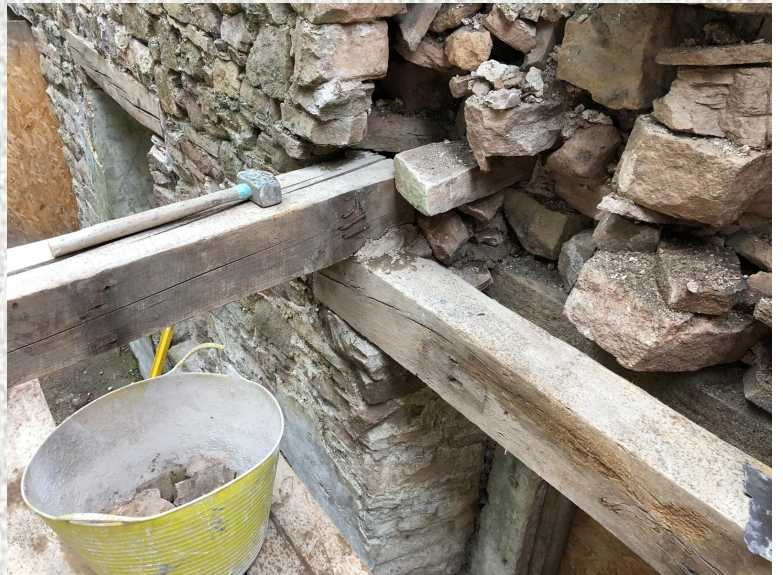
***Reclaimed oak beams were used in the reconstruction.***

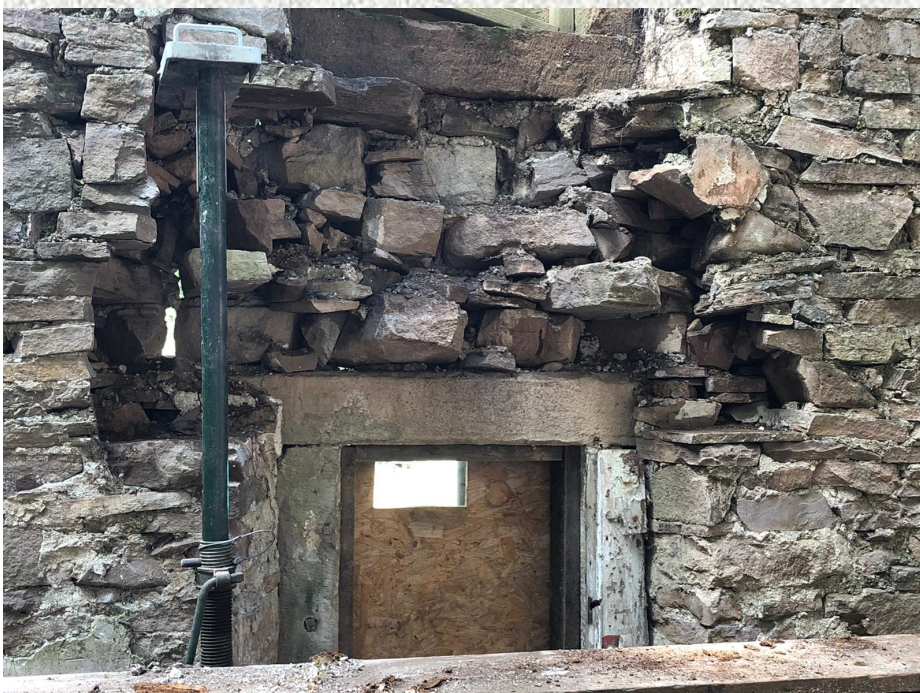
***Parlour window ready for replacement lintels. Note the inner and outer walls and "through" stones.***

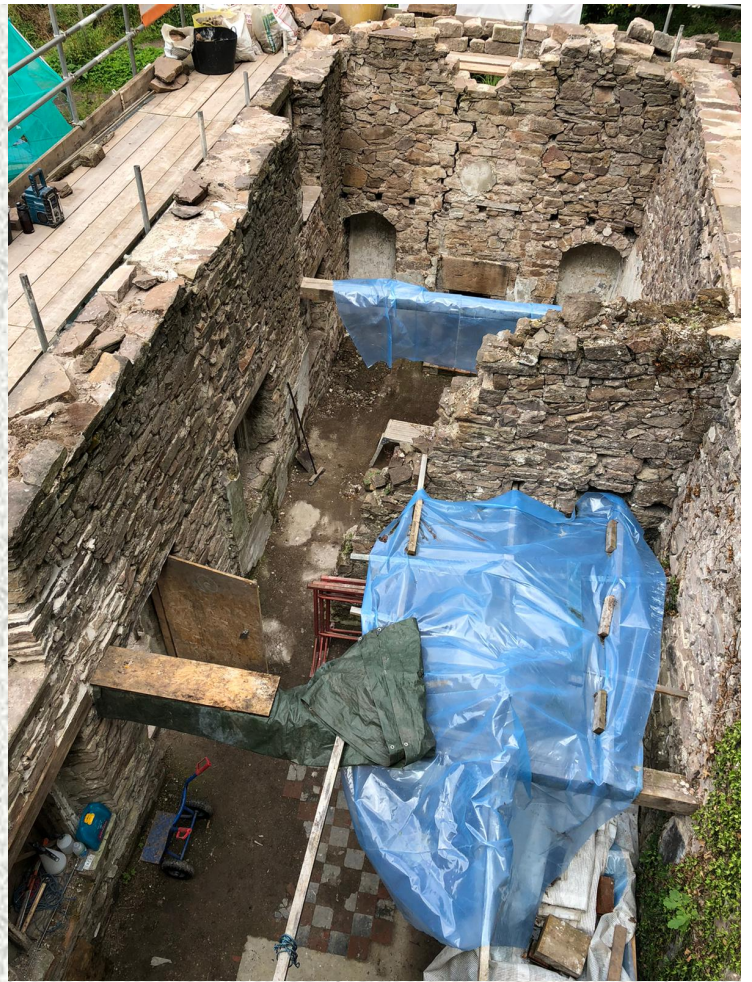
***The two main beams installed.***
